Ryan House Feasibility Study

In April 2019, ARG conducted a preliminary interior and exterior condition assessment of the Ryan House. The goal was to gain an understanding of the general conditions of the house's various architectural components and to provide a framework as to what repairs might be needed as part of a larger rehabilitation project. A more detailed condition assessment should be undertaken as part of any future project, ideally with most of the furnishings removed, so that all parts of the house are visible.

RYAN HOUSE FEASIBILITY STUDY: AS-BUILT DRAWINGS

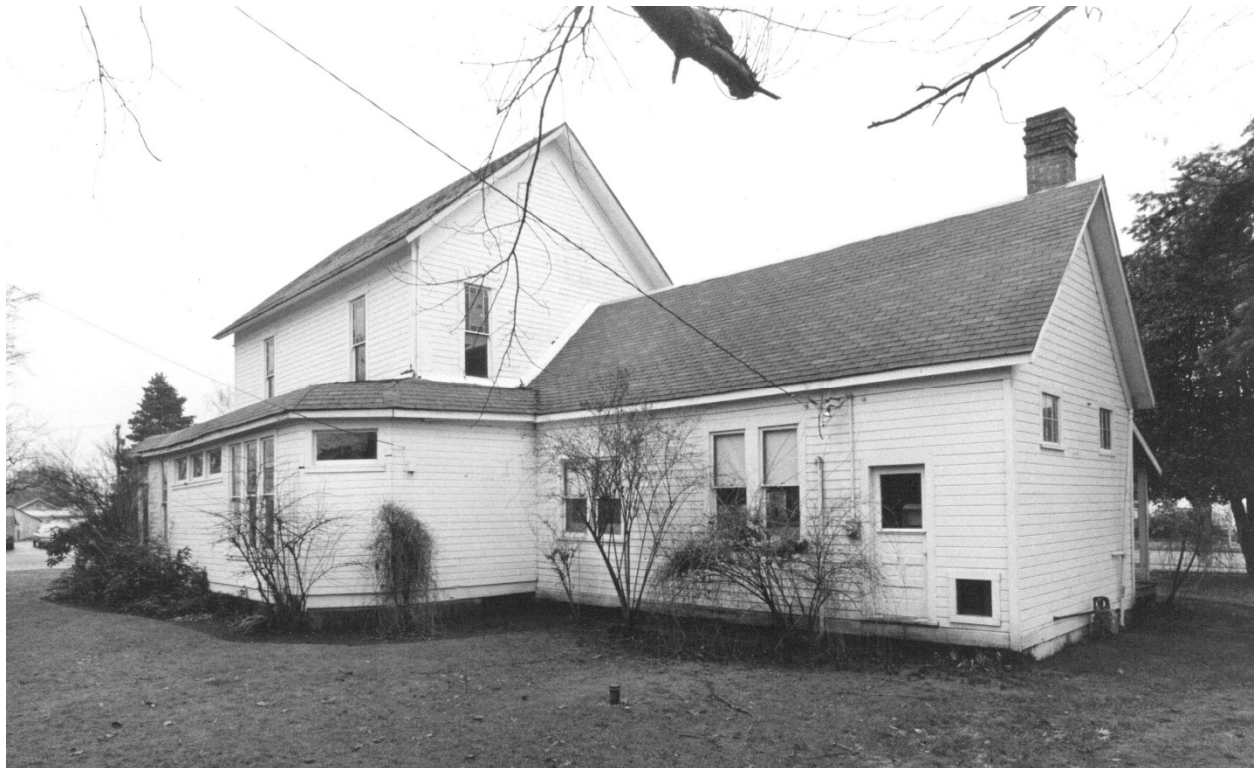
Image from the 1976 National Register nomination, showing the enclosed west veranda. This portion of the veranda has since been restored to its original open condition.

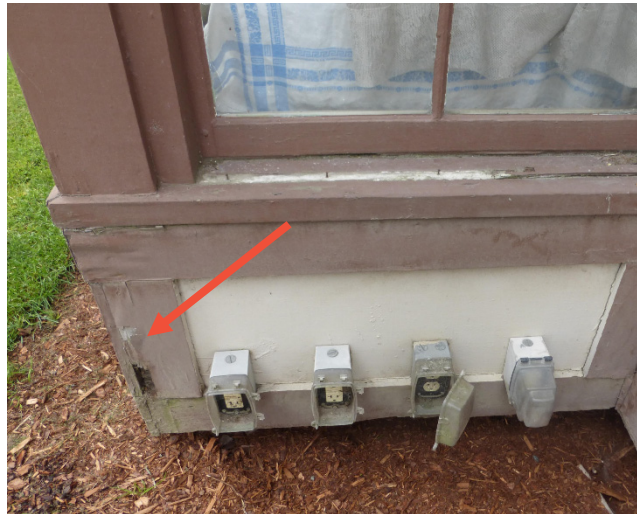
Siding Conditions

Horizontal lap siding, corner boards and wood trim are in fair to good condition with several areas needing repair. Siding and trim should also be repainted within the next two to five years. New paint should match original paint color (based on a paint analysis).

Repair siding in missing or damaged locations. Assume 5%-15% wood siding/trim replacement.

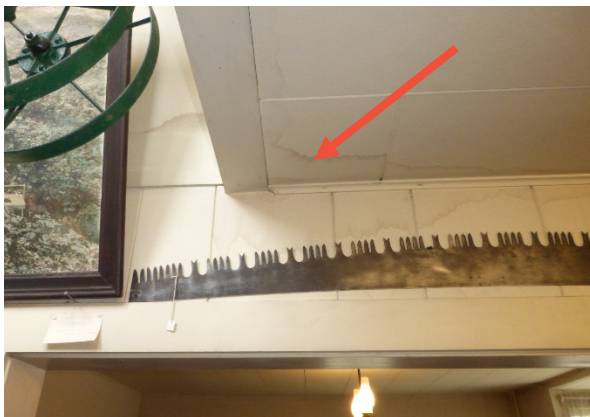
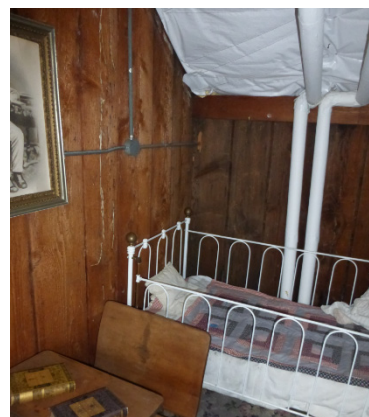
Pioneer Cabin Addition: Walls and ceiling are painted pressed fiber panels, most likely over the original wood paneling. Many of the fiber panels in ceiling areas exhibit water damage and discoloration. The attic over the Pioneer Cabin and later addition has been left unfinished.

Before any interior finishes are repaired, the exterior roof and siding should be repaired to a watertight condition. Once this has been done, all cracked plaster should be repaired. Any plaster that is damaged beyond repair should be replaced. Any cracks or scratches in wood trim elements (including handrail and balusters) should be repaired. Final paint, stain and wallpaper selections should be based on the interpretive plan. For example, if the period of significance of the Victorian Farmhouse and the Pioneer Cabin date to their construction completion dates, the finish appearance (paint, stain, wallpaper color, etc.) will be different then if they are to be interpreted to when the property passed to City of Sumner ownership (1926). During repairs, insulation should be added to the walls if it has not been added already (it has been added to the roof). This will help with utility costs. Also, if the radiator piping is removed, holes in ceiling and walls should be repaired.

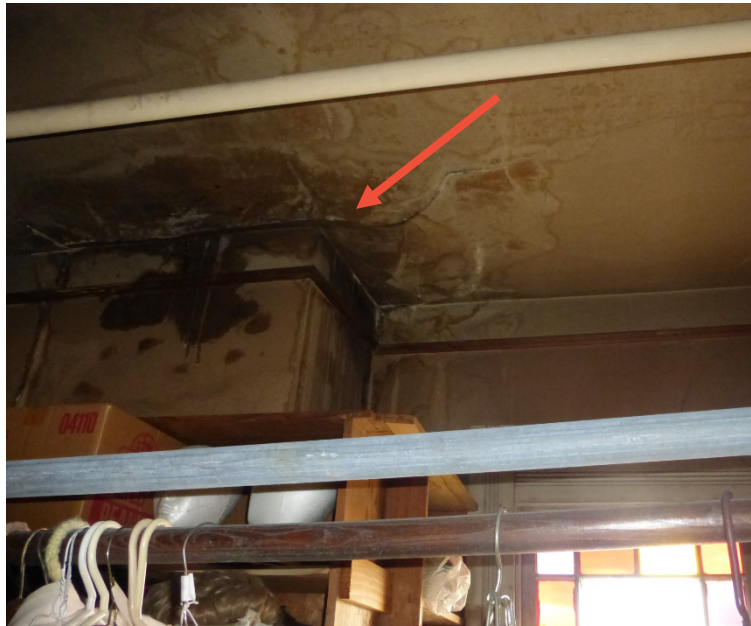
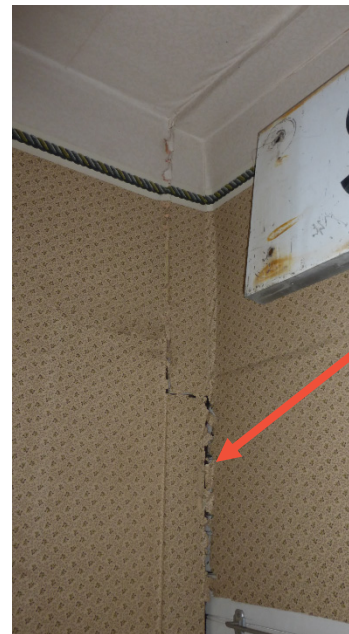
Victorian Farmhouse: The walls in the finish spaces are comprised of plaster walls (painted or covered with wallpaper) and plaster ceilings (painted). Walls in unfinished spaces (such as the attic) are exposed wood structure. The Parlor, Entry, Dining Room, staircase and upstairs bedrooms all have a decorative wood base, wood trim around the doors and windows and a picture mold that runs around the perimeter of the room. The Dining room also has a wood wainscot and a decorative wood mantelpiece around the brick fireplace. Wood base and trim elements are either stained or painted. In general, all of the finishes are in fair condition. Plaster is cracked and stained from water ingress at ceilings in many locations, wallpaper is peeling and the wood stain/lacquer exhibits weathering and surface damage.

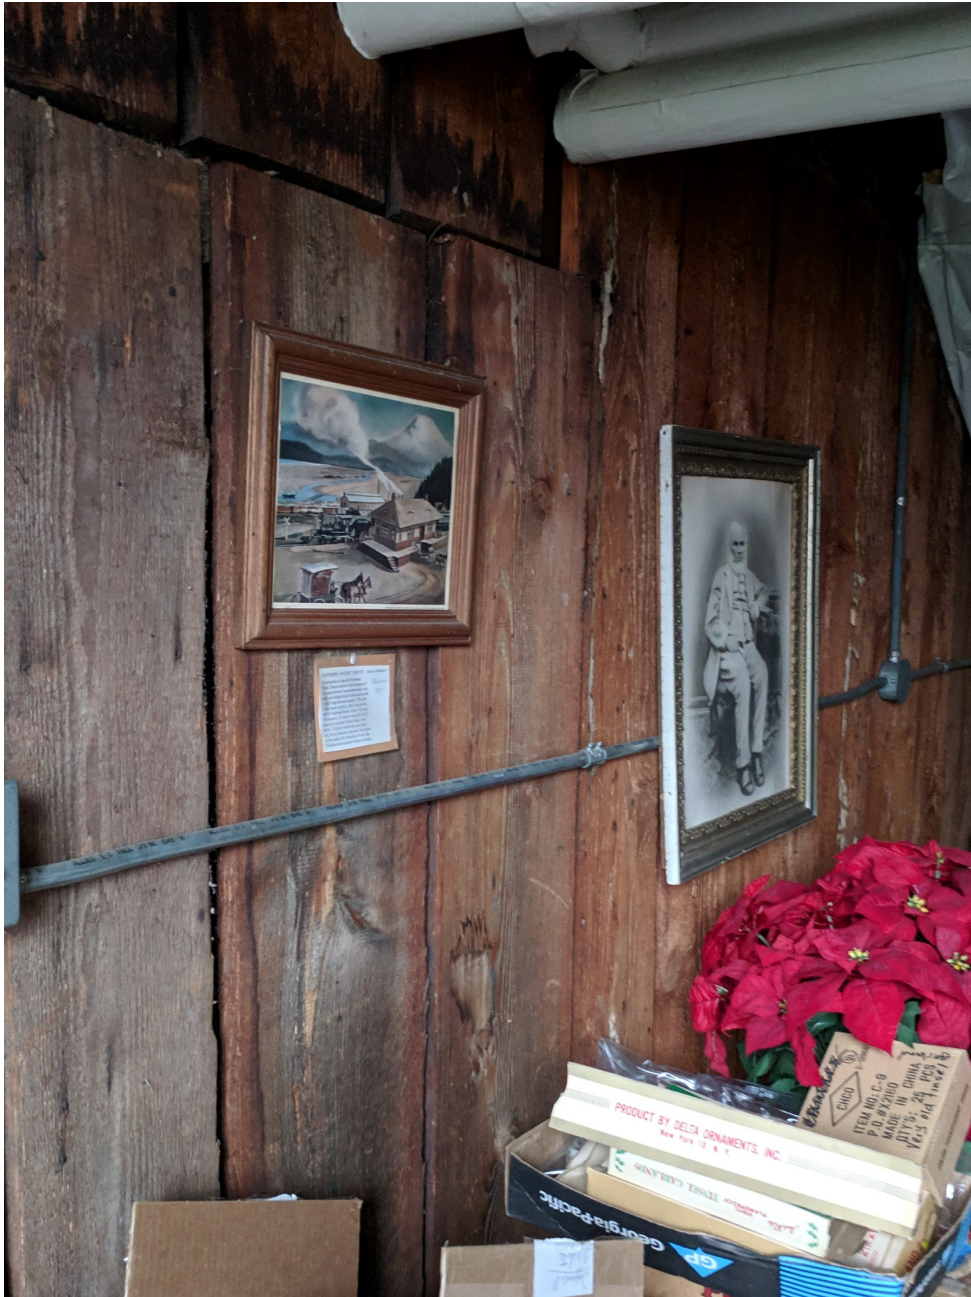
Figure A17. Portions of the original bare plank walls are visible in the cabin attic (Architectural Resources Group, April 2019).

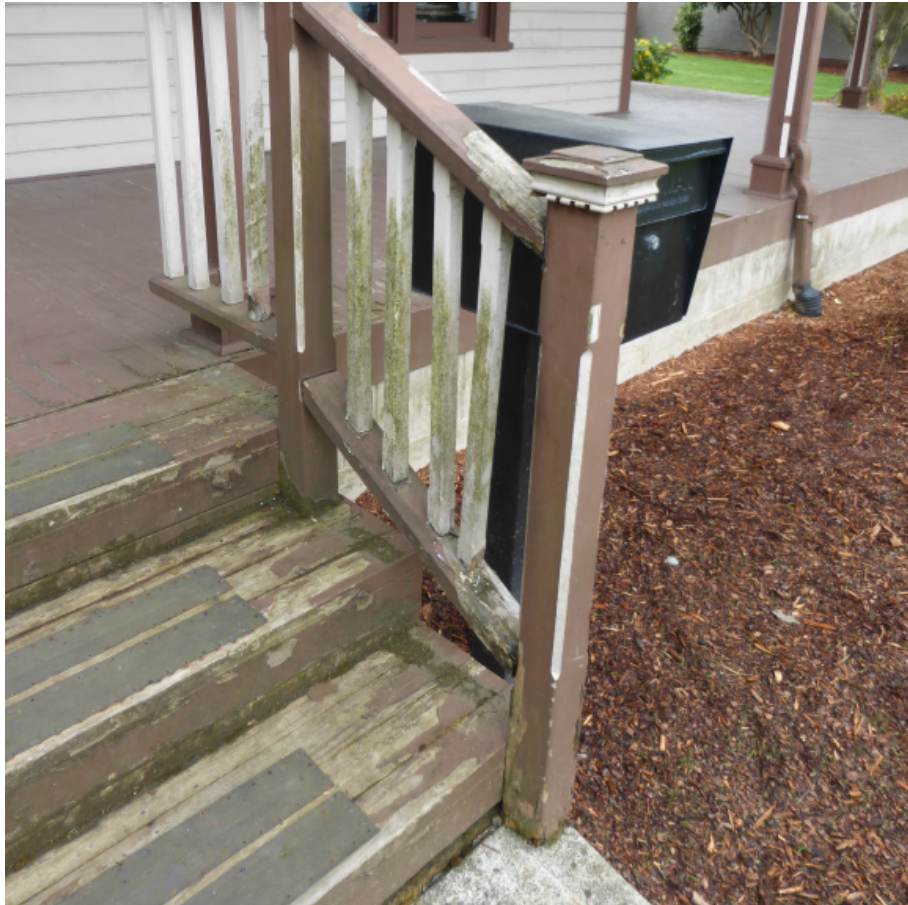
Example of deteriorated wood at porch stairs and railings to be replaced.
